PRO VANTAGE

HOME INSPECTION SERVICES

100 Main Street, Yourtown MD 20000

Inspection Date: October 13, 2022

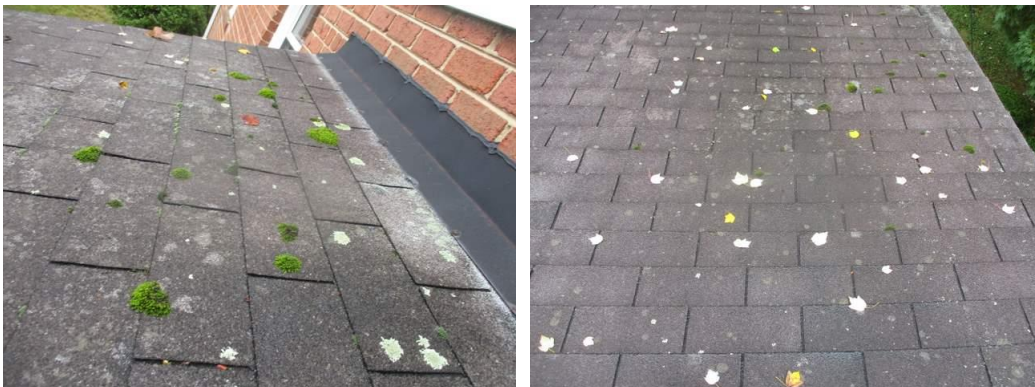
Some moss and algae growth noted on the roof which can deteriorate roof shingles. Professional cleaning recommended.

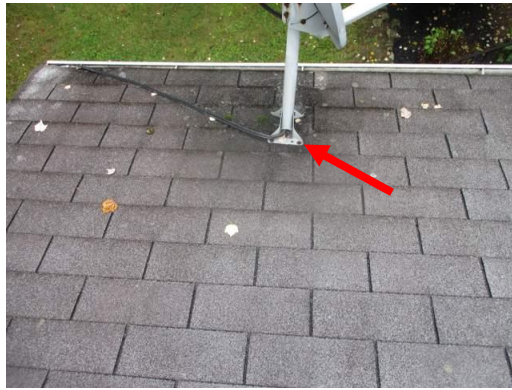
The bolts securing the satellite dish at the front of the house may make the roof in this area susceptible to moisture intrusion. Recommend further evaluation by a qualified roofing contractor.

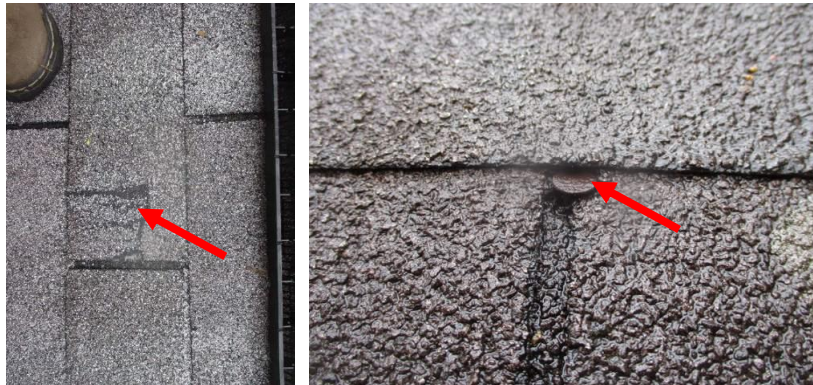
Some minor damage on the shingles and exposed nails noted on the roof. Recommend further evaluation by a qualified roofing contractor.

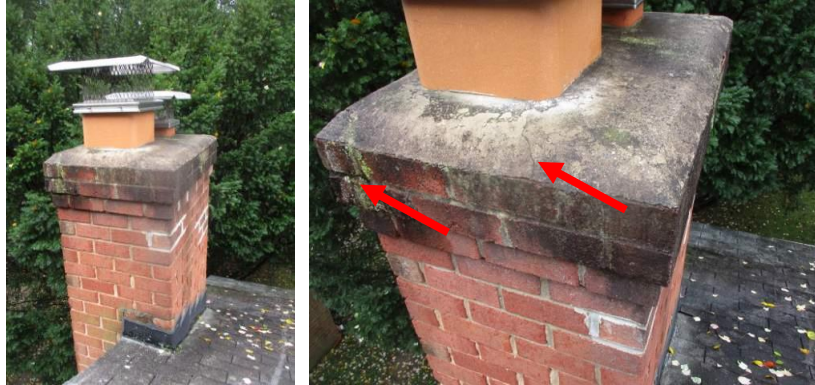
The chimney flashing is in acceptable condition.

Some mortar improvements may be needed for the chimney brick at the top courses. Minor cracks noted in the chimney crown. Recommend further evaluation by a qualified chimney sweep contractor.

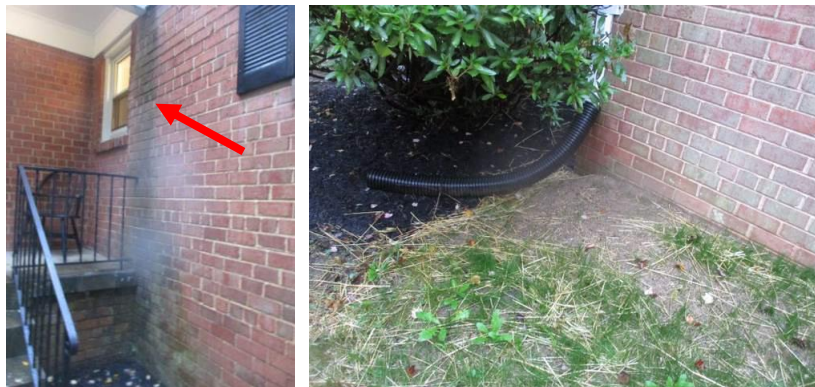
Evidence of possible gutter leaking noted at the right side of the front porch. Recommend further evaluation by a qualified roofing contractor. Additional kick-out flashing may be needed.

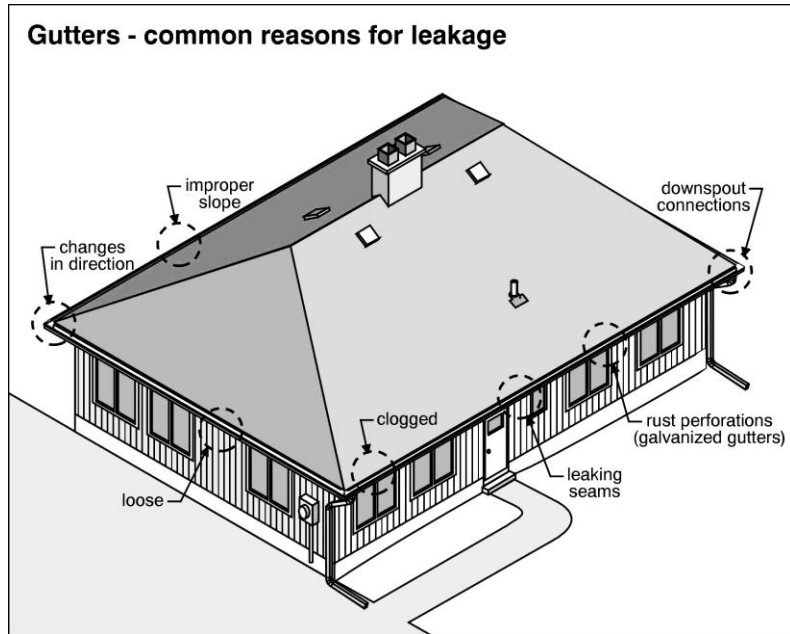
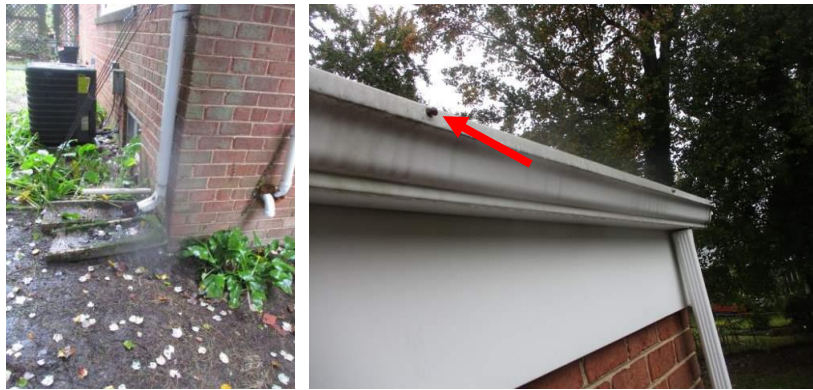
Recommend extending the downspout and the sump pump drain at the back left of the house.

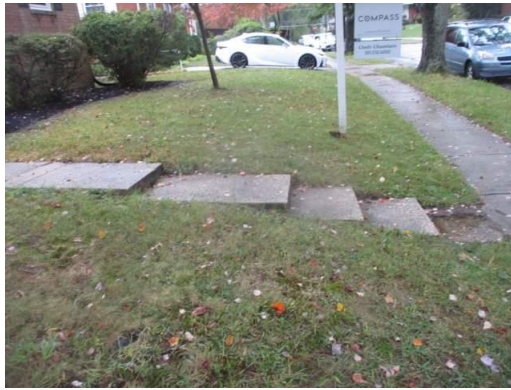
The concrete has settled and water is pooling in sections of the walkway. Improvements recommended by a qualified contractor.

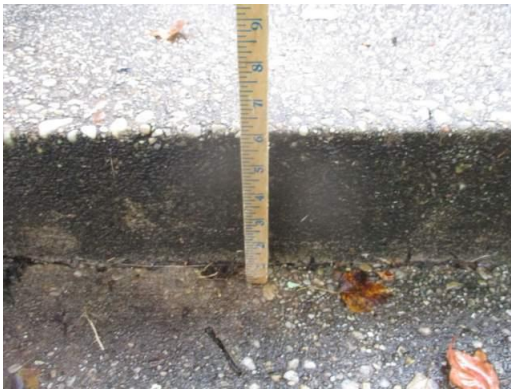
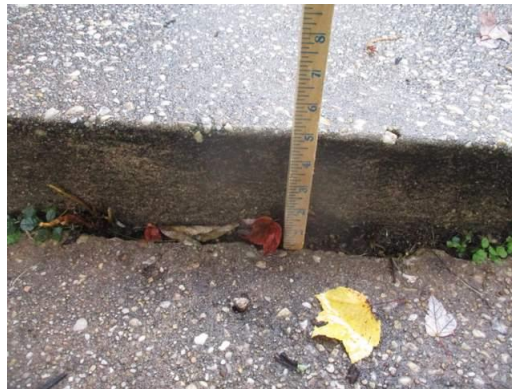
Step height variances noted at the front entrance walkway, presenting a possible trip hazard. Caution or alteration recommended.

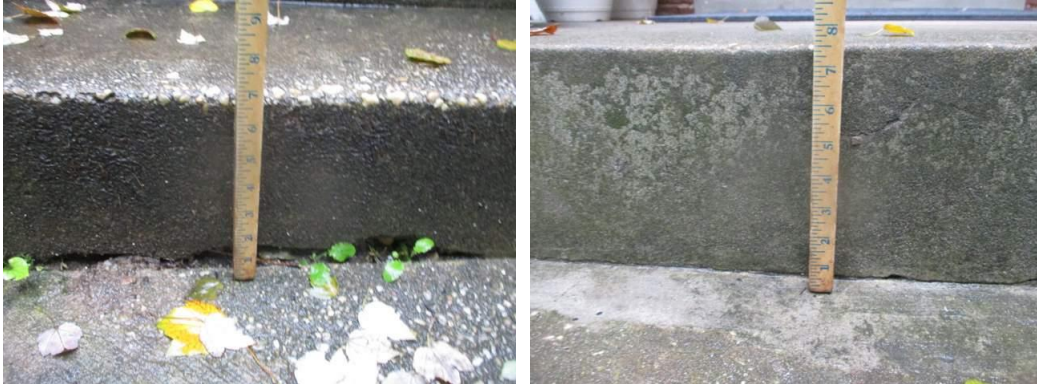
Step height variances noted at the front porch stairs, presenting a possible trip hazard. Caution or alteration recommended.

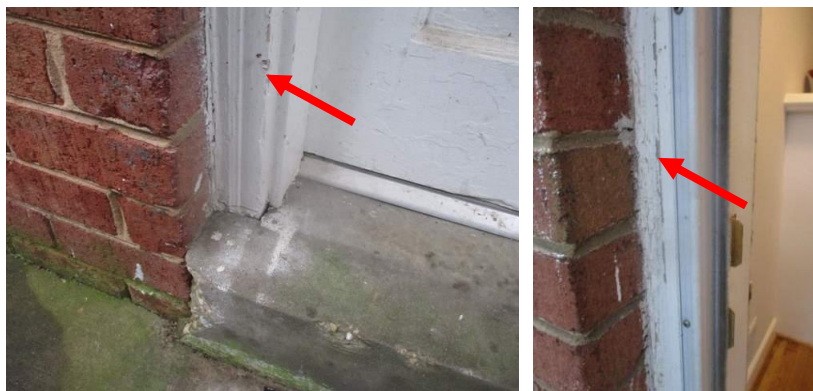
Caulking and painting improvements needed around door and window trims around the house.

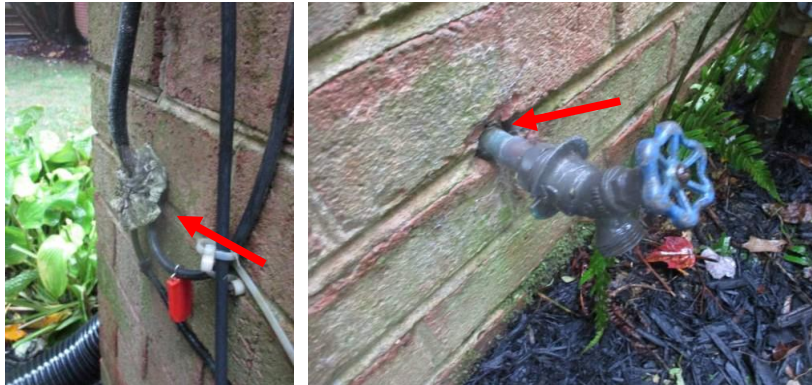
Recommend sealing the gap where the service entrance cable passes through the brick siding at the front of the house.

Recommend sealing the gap around the front hose bib.

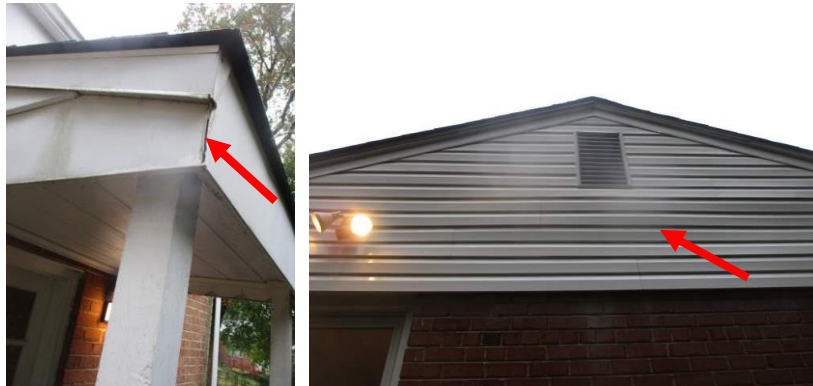
Caulking improvements needed around the aluminum and vinyl siding.

The vinyl siding covering the gable end at the back of the house appears to be loose. Recommend further evaluation by a qualified siding contractor.

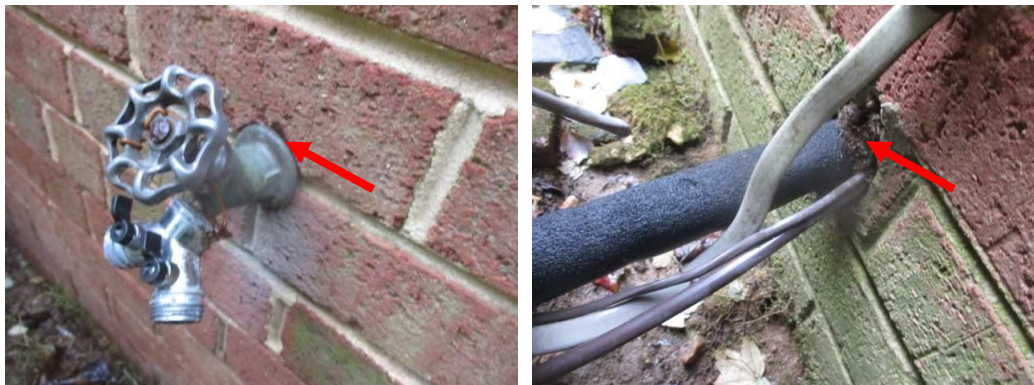
Recommend sealing the gap around the hose bib at the back of the house.

Recommend sealing the gap where the condensing unit refrigerant line passes through the brick siding at the back of the house.

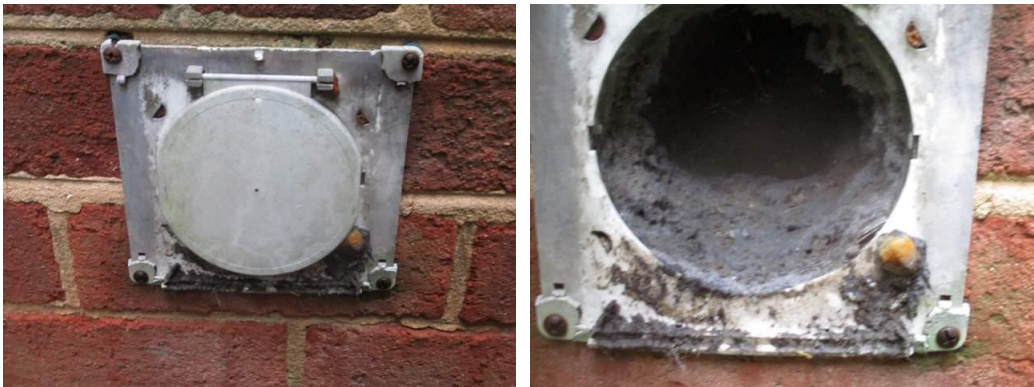
Recommend keeping the dryer vent and vent cover clear of lint to reduce fire risk. Minimum yearly cleaning of the dryer vent recommended. Missing hood/cover noted, repair recommended.

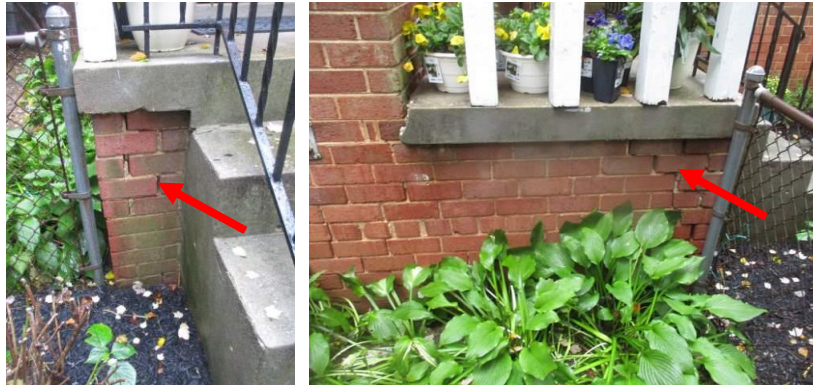
The front porch brick and foundation is deteriorating and appears to be settling. Repairs recommended by a qualified masonry contractor.

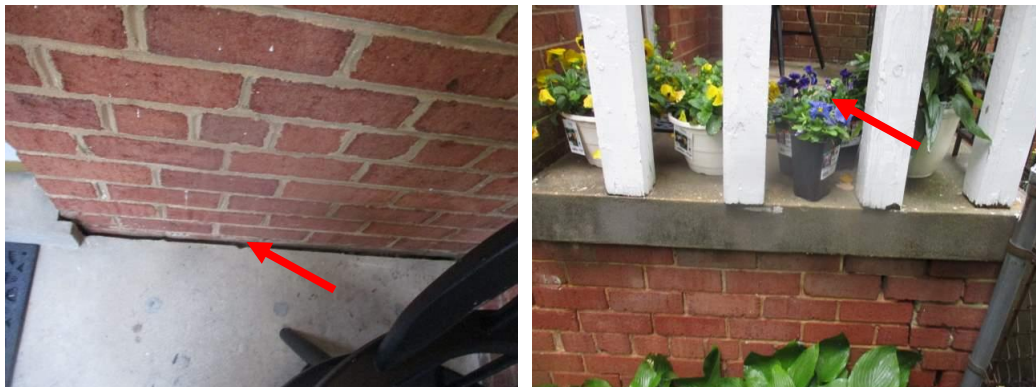
Recommend sealing the gap between the front porch slab and the brick wall.

The gaps are wider than recommended between the front porch rail spindles. Safety improvements recommended.

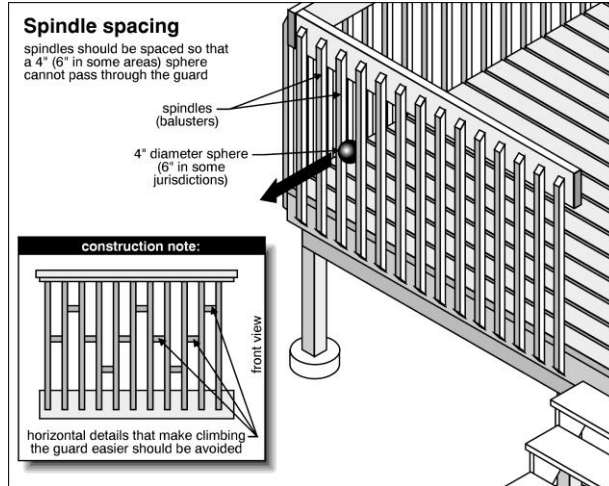
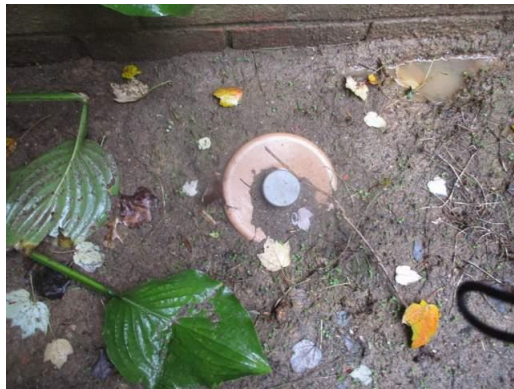
Drilled holes in the front porch concrete landing indicate previous termite treatment as well as other evidence of previous pest treatment noted around the house. **Recommend pest control management.**

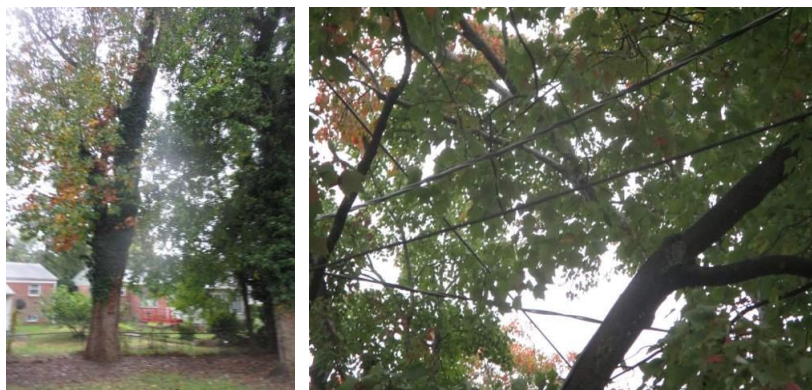
There are a number of large trees close to the house. Recommend periodic evaluation by a licensed tree service to preempt any possible falling limbs or trees.

Recommend having a licensed professional cut back trees from the electric wire drop from the street.

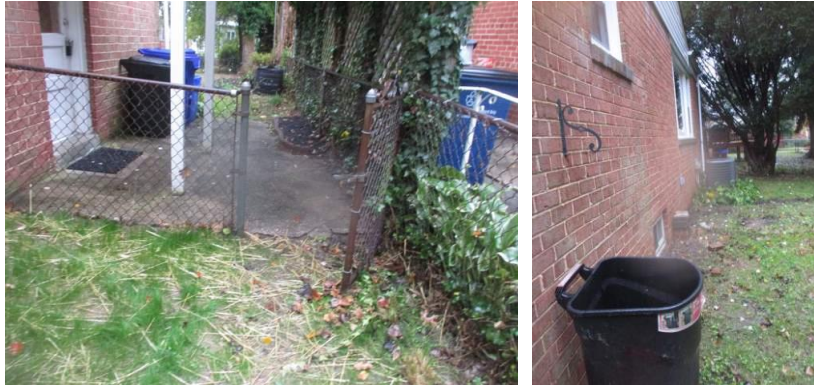
The concrete slab on the right side of the house appears to be settling. Recommend further evaluation by a qualified concrete contractor.

Grading improvements recommended at the back of the house.

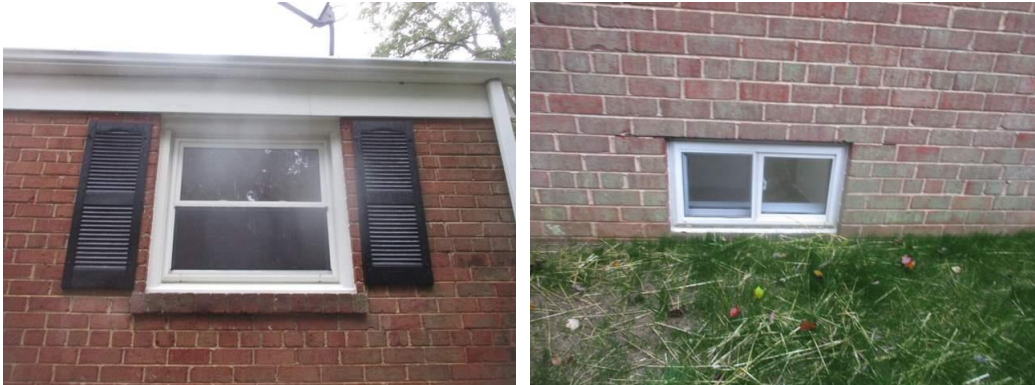
The windows are capped with trim wrap which generally helps prevent rot and deterioration; however, periodic caulking will be needed. Some caulking is recommended at this time.

The basement windows on the right side of the house are too close to grade. Recommend installing window wells by a qualified contractor.

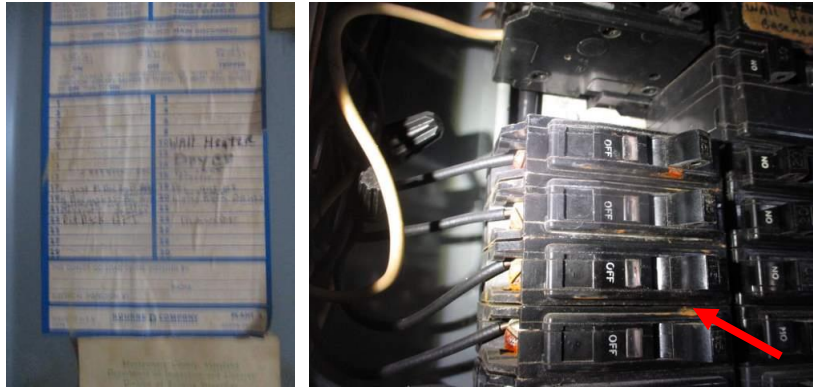
Recommend labeling improvements for the electric panel.

There is some corrosion noted on several breakers. Recommend further evaluation.

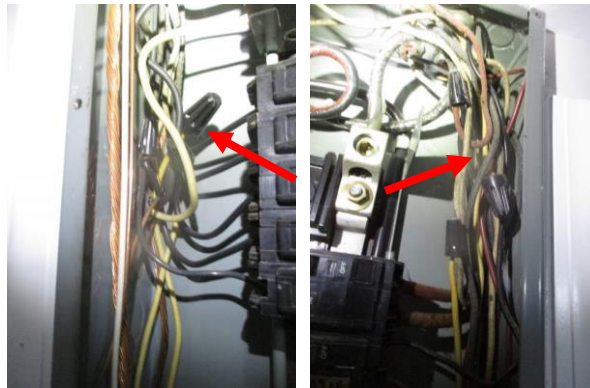
There are multiple wire conductor splices within the panel. Further evaluation by a licensed electrician recommended.

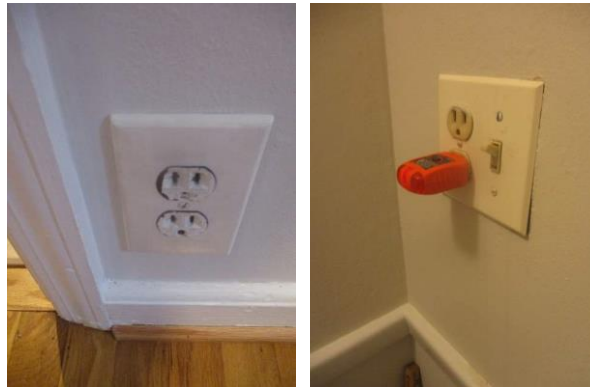
There are several painted over receptacles throughout the house. They are therefore technically damaged/altered and should be replaced. We may not have been able to test all of the painted over receptacles as paint was obstructing some of the receptacles.

The receptacle near the sink in the basement half bathroom is not GFCI protected. Recommend replacing.

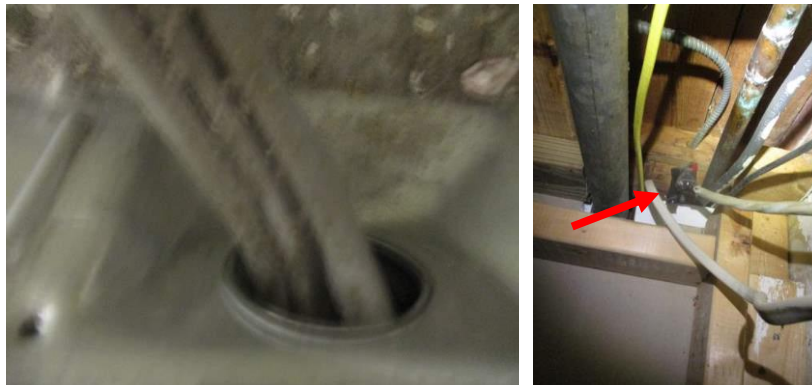
The dryer cable connector is missing on the dryer. Recommend installing.

An unapproved electric wire conductor splice noted in the basement ceiling. Recommend further evaluation.

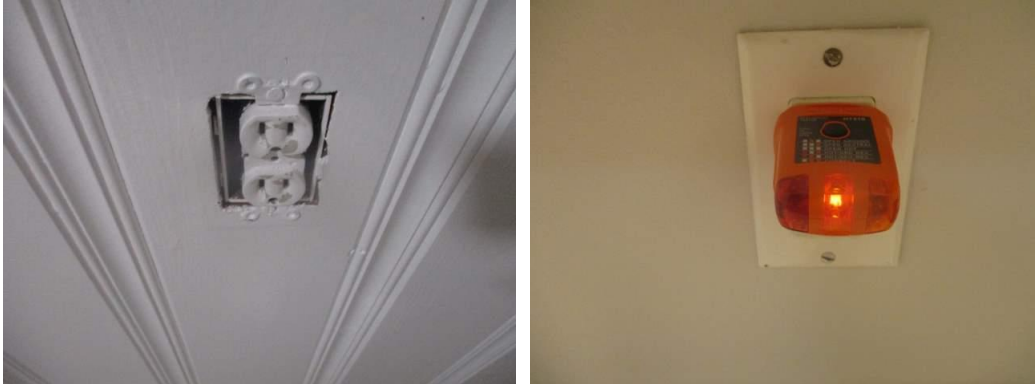
Recommend installing a receptacle cover on the back wall of the basement front right room.

The GFCI receptacle above the ground level bathroom sink is showing open ground. Recommend further evaluation.

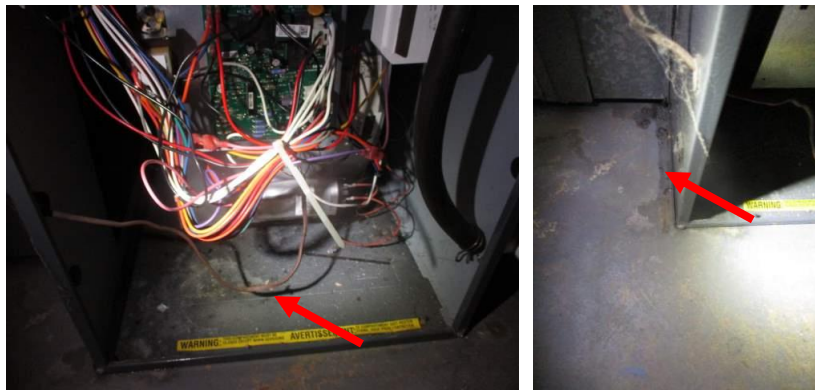
Recommend cleaning the interior of the gas furnace.

Some moisture noted around the bottom of the gas furnace. Recommend further evaluation.

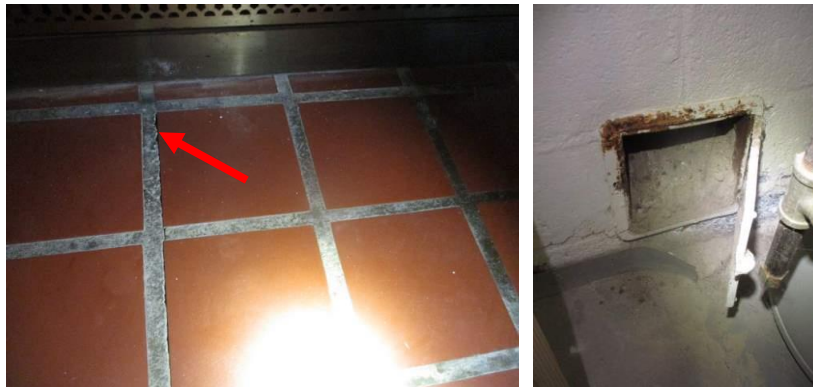
Grouting improvements recommended in the hearth in front of the fireplace.

Recommend cleaning the ash pit for the wood fireplace by a qualified chimney sweep contractor.

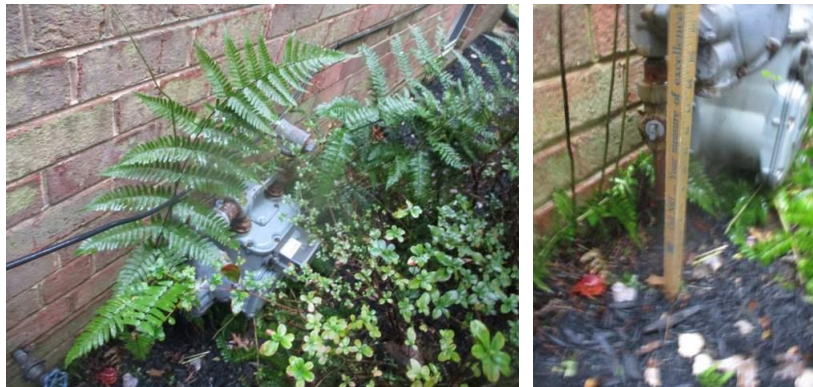
The gas main shut off valve is located at the gas meter at the front of the house. This can only be shut off using a med-large size wrench and we recommend having such a wrench available in case of emergency.

The gas meter vent screen may be lower than recommended. Recommend further evaluation by a licensed plumber.

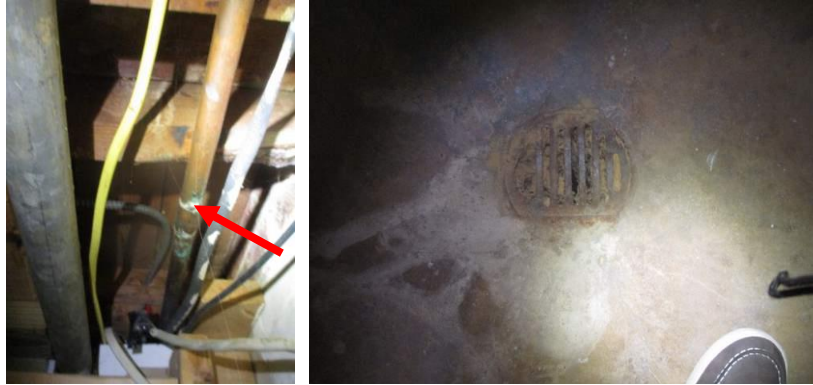
Some corrosion noted on some copper pipes. No leaking noted at the time of inspection. Recommend monitoring.

Recommend cleaning the floor drain in the basement.

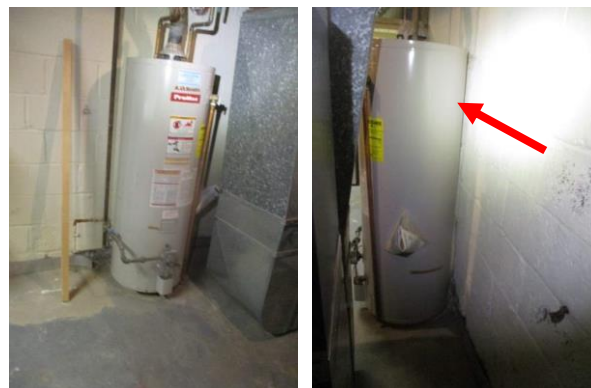
The water heater clearance with the foundation wall may not be adequate. Recommend further evaluation by a licensed plumber.

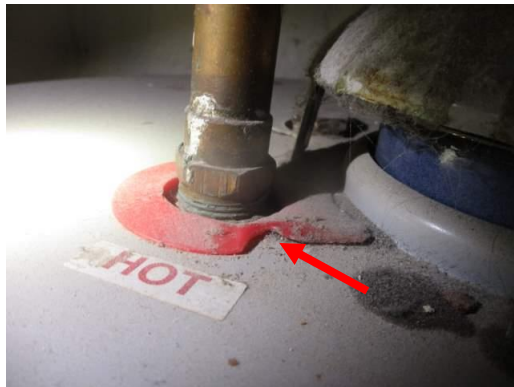
Melted plastic rings at the top of the water heater may indicate back drafting or improper operation of the unit generally caused by lack of combustion air supply. Back drafting can allow hazardous combustion gases to enter the home. Safety evaluation by a qualified professional recommended.

Foil tape is not approved to seal off combustion vents. Safety evaluation recommended.

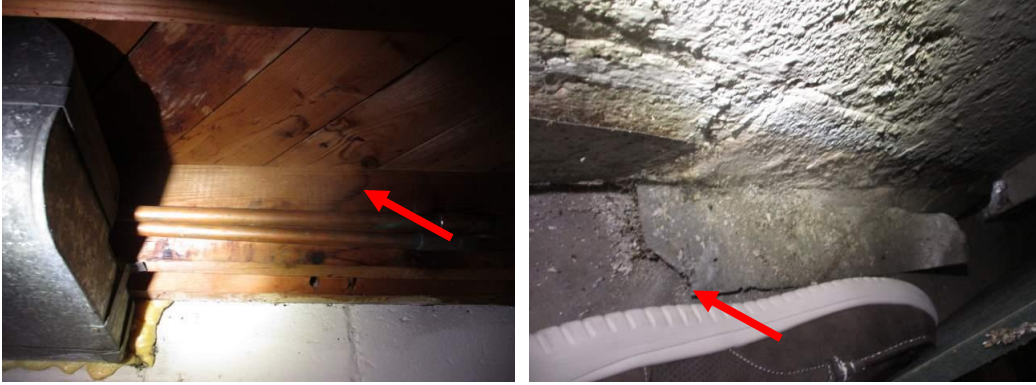
Evidence of previous moisture stains noted in the floor framing and floor boards in the basement. Areas tested dry at the time of inspection. Recommend monitoring.

Deteriorating conditions noted at the perimeter metal flashing that was installed for water treatment in the basement. Recommend further evaluation by a qualified contractor for possible replacement.

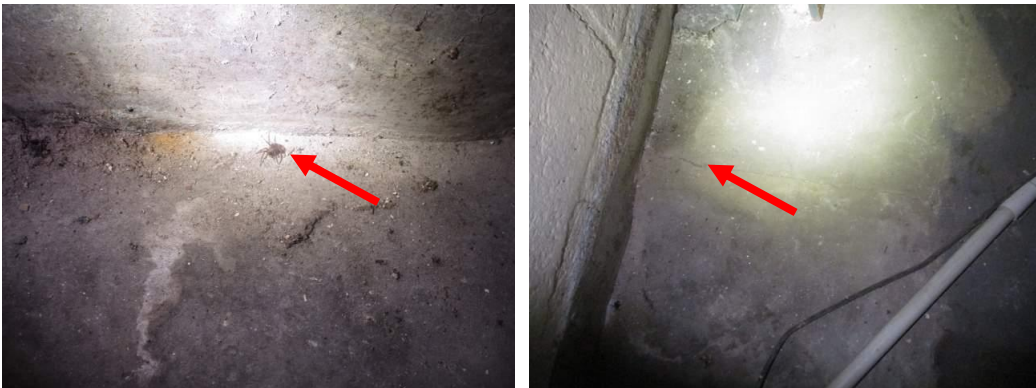
Some wildlife presence noted in the basement. Recommend pest control management.

Fairly typical cracks noted in the basement concrete floor. Recommend monitoring.

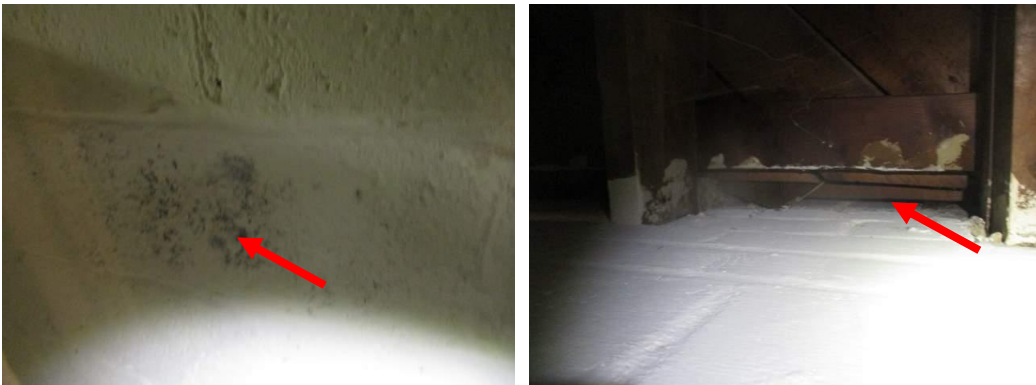
Evidence of efflorescence noted in the block foundation wall. Efflorescence occurs when moisture passes through masonry, leaving mineral deposits on the surface. Recommend monitoring.

Recommend sealing the gaps between the floor framing and the block walls to improve fire safety.

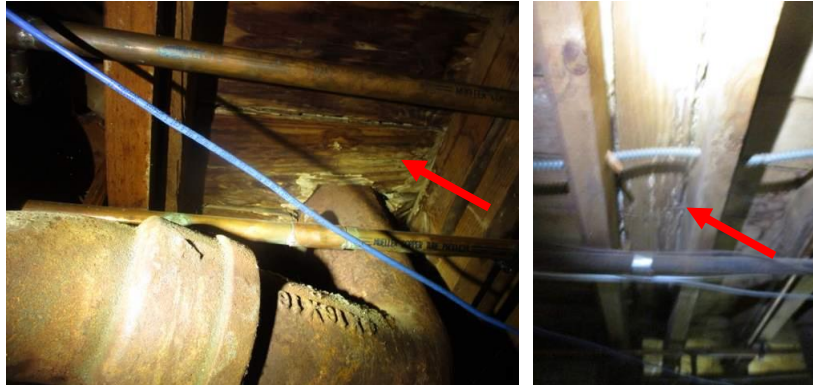
Previous moisture stains and damage noted on the floor boards and floor joists around plumbing drain pipes and below the tub. These areas tested dry at the time of inspection. Recommend monitoring.

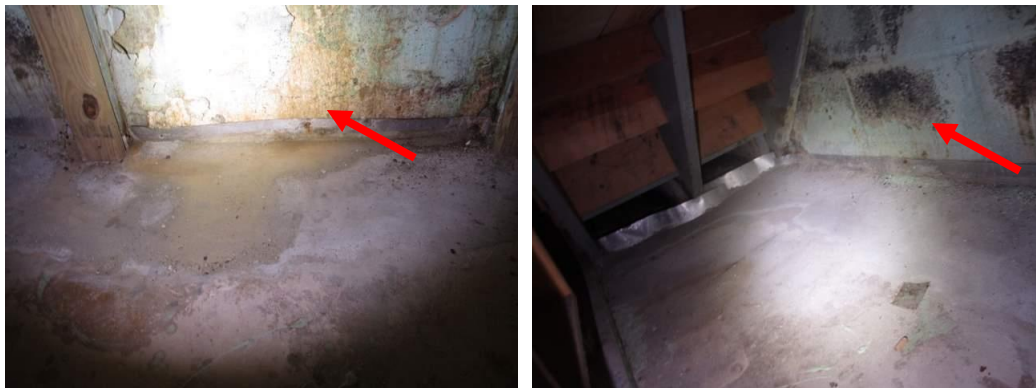
Efflorescence and evidence of possible mold-type substances noted under the basement stairs. Recommend cleaning and improved ventilation under the stairs. Most moisture control measures begin with grading, gutter, and downspout improvements at the exterior.

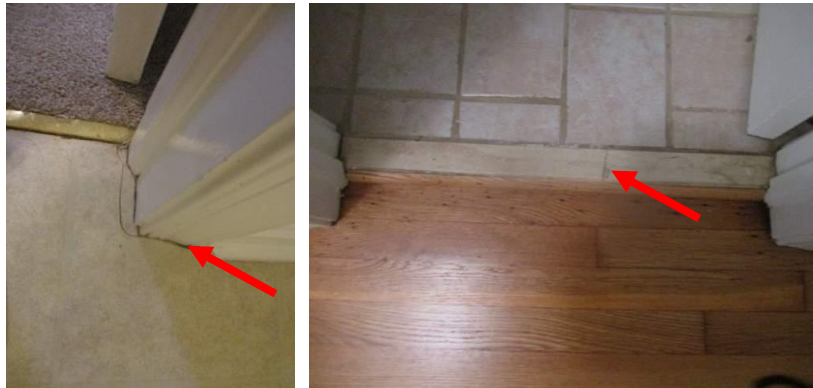
Recommend caulking where the flooring in the basement half bathroom meets the trim and the doorjamb.

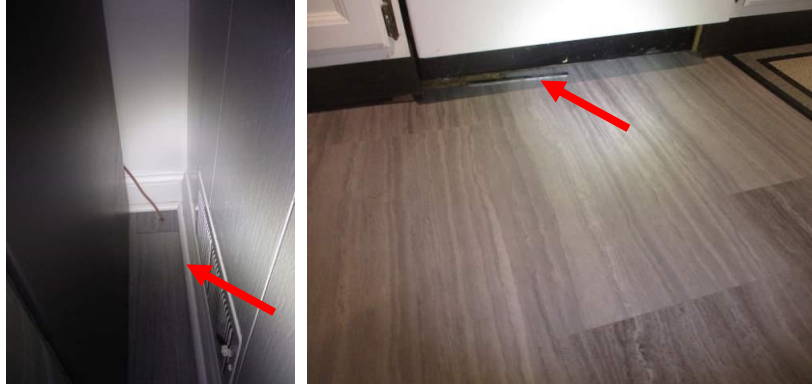
Gaps noted around the perimeter of the kitchen floor. Recommend sealing the gaps by a qualified flooring contractor.

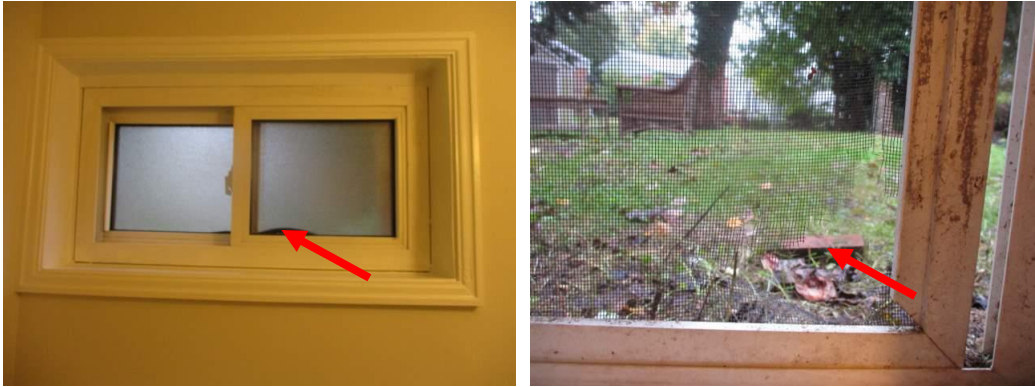
The interior seal in the basement half bathroom window is coming loose. Recommend repair or replacement.

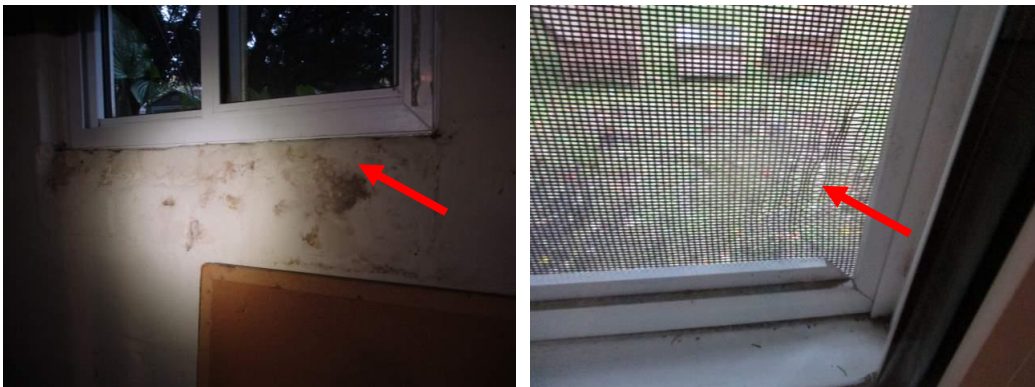
Evidence of previous moisture noted below the basement front window. Recommend monitoring.

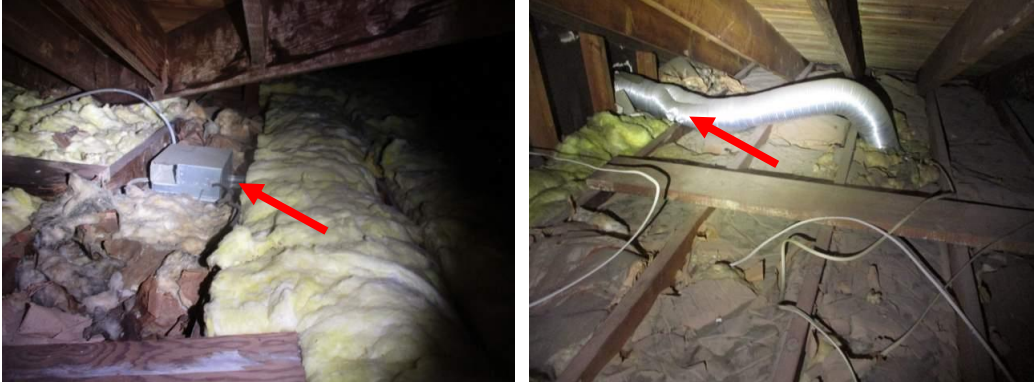
The ground level bathroom exhaust vent is not ducted to the outside, resulting in evidence of moisture, condensation, and possible mold-type substances in the attic. Extending the duct to the outside through the roof is needed by a qualified contractor.
