PRO VANTAGE

HOME INSPECTION SERVICES

100 Main Street, Yourtown MD 20000

Inspection Date: October 13, 2022

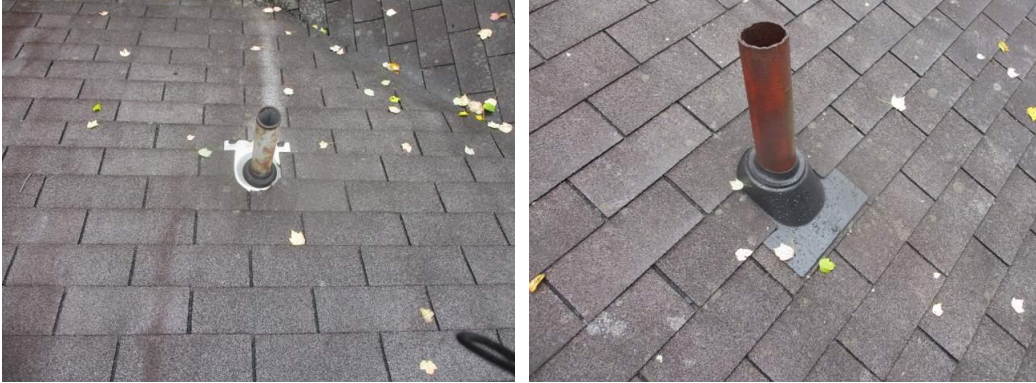
Stack boots and vent hood flashings appear to be in acceptable condition.

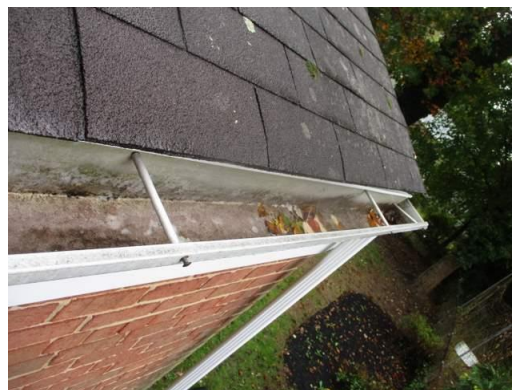
The gutters do not have guards or screens to prevent debris from accumulating. **Routine cleaning maintenance recommended.**

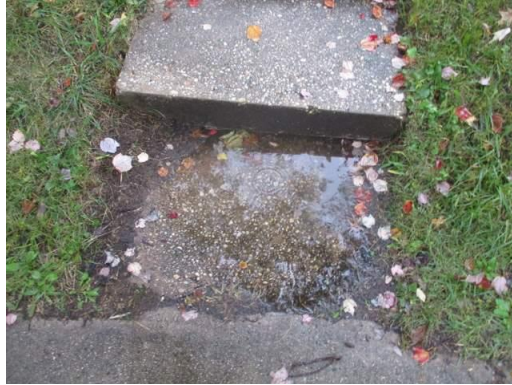
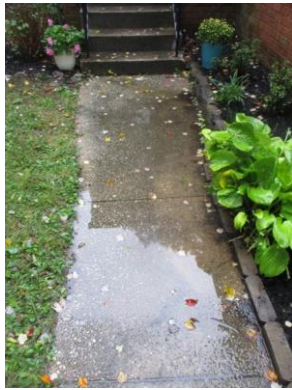
The concrete has settled and water is pooling in sections of the walkway. Improvements recommended by a qualified contractor.

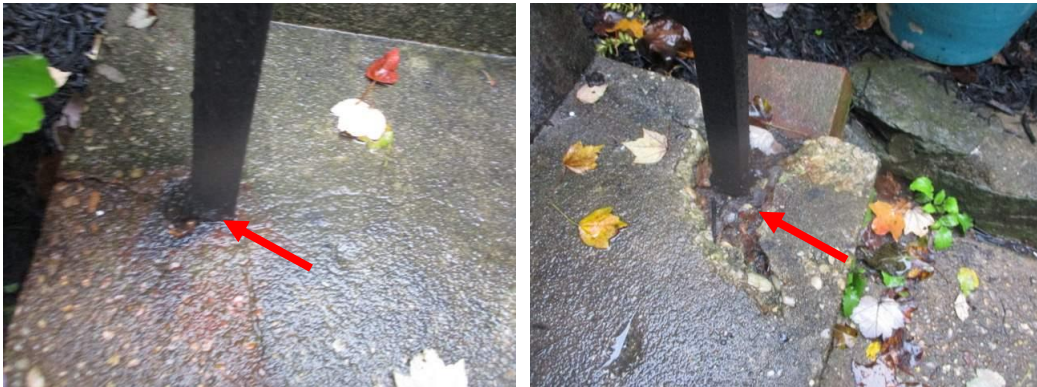
Railings will need to be kept rust proofed, especially where they sit in the concrete. Sealing the depressions with a self-leveling concrete caulk will help to shed water and may reduce further rusting. Concrete repairs needed at the bottom right of the front entrance steps.

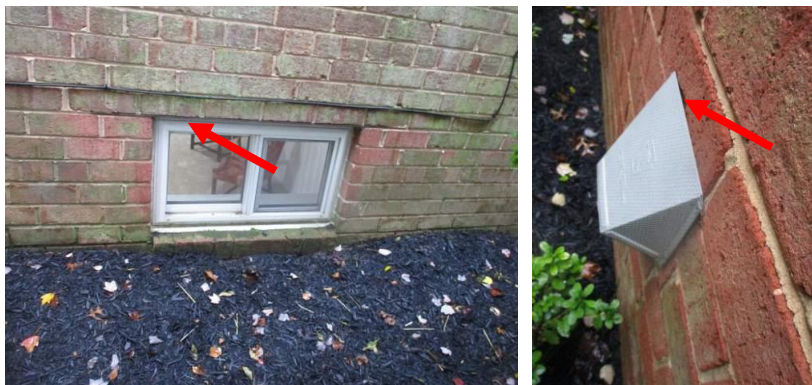
There are steel lintels above the basement windows. Recommend keeping all steel lintels rust proofed.

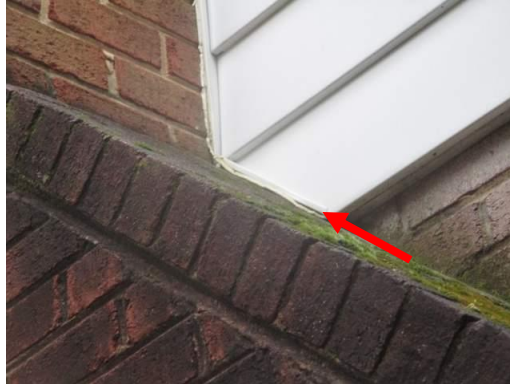
Caulking improvements recommended where the siding meets the brick in various places around the house.

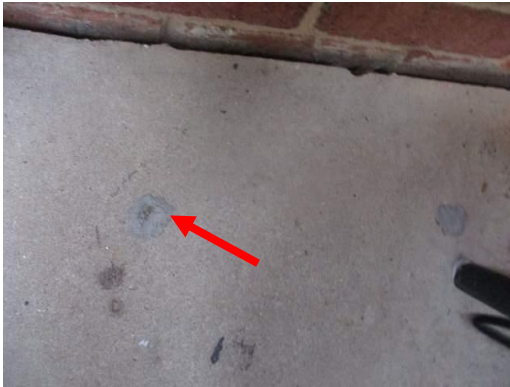
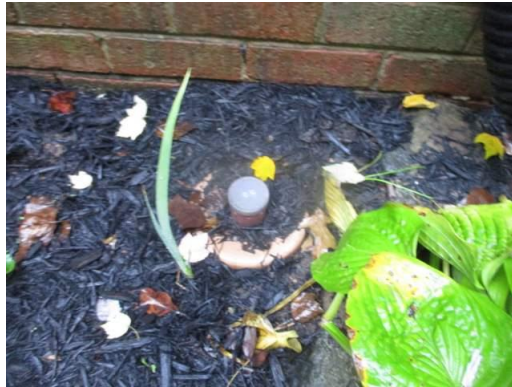
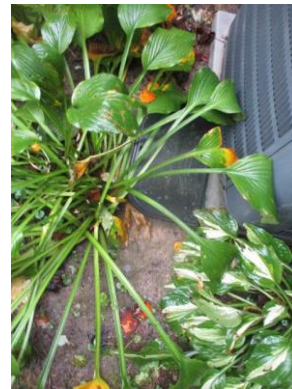
Drilled holes in the front porch concrete landing indicate previous termite treatment as well as other evidence of previous pest treatment noted around the house. **Recommend pest control management.**

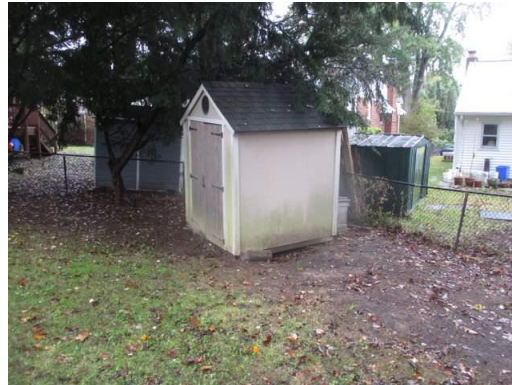
Grading improvements recommended under the shed.

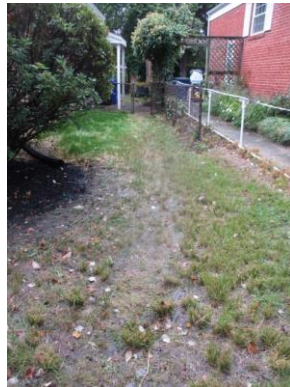
Grading improvements recommended on the right side of the house to improve drainage.

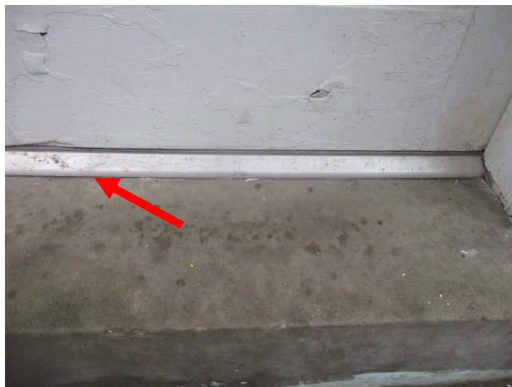
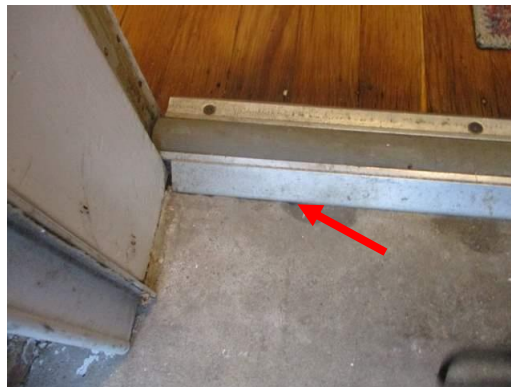
Caulking improvements recommended under the threshold of the right entry door.

Caulking improvements recommended under and around the front door threshold.

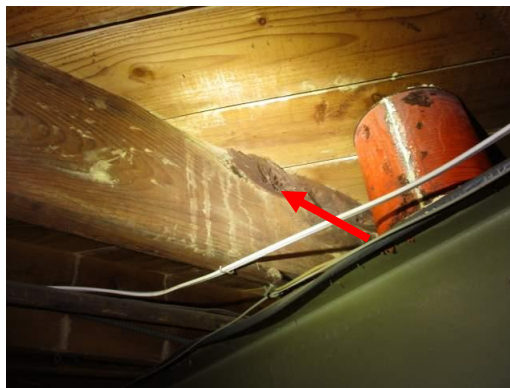
Deteriorating large wood knot noted in one floor joist in the basement. Recommend further evaluation by a qualified contractor for possible strengthening of this joist.

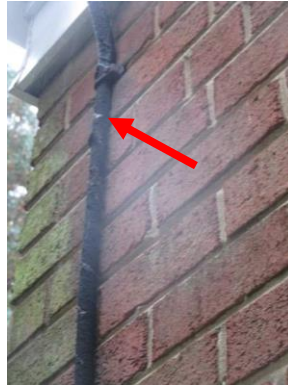
The service entrance cable is deteriorating. Recommend replacement by a licensed electrician.

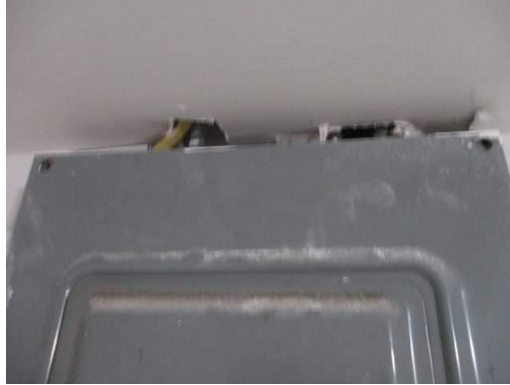
The electric panel cover is missing two screws. Recommend adding screws to the panel cover.

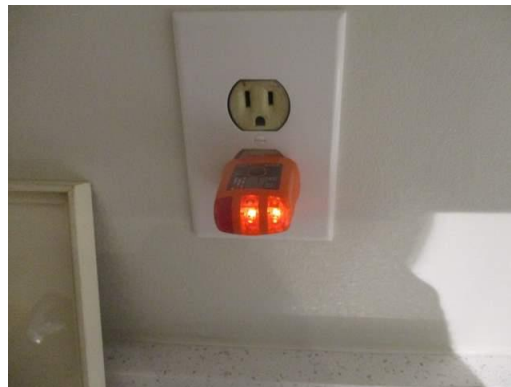
The two receptacles above the countertop in the kitchen are not GFCI protected. Recommend replacing.

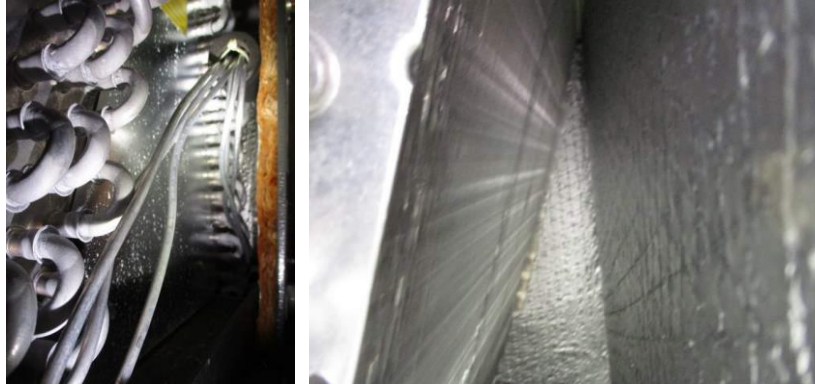
The AC coils are in acceptable condition.

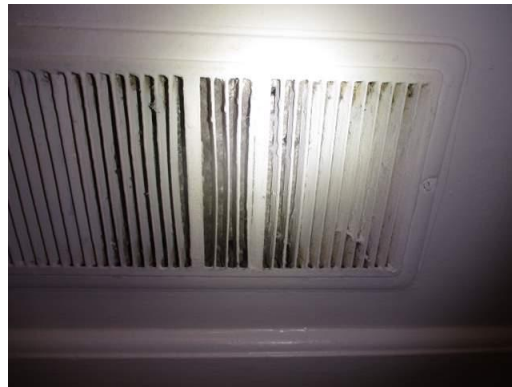
Duct cleaning recommended.

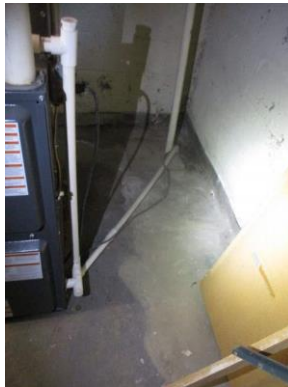
Condensate line extends to and drains into the sump pump.

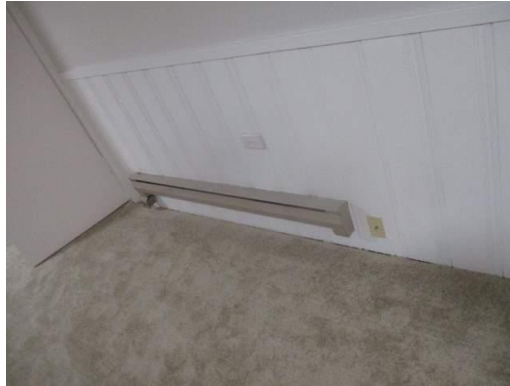
There is a functional electric baseboard heater in the basement front right room.

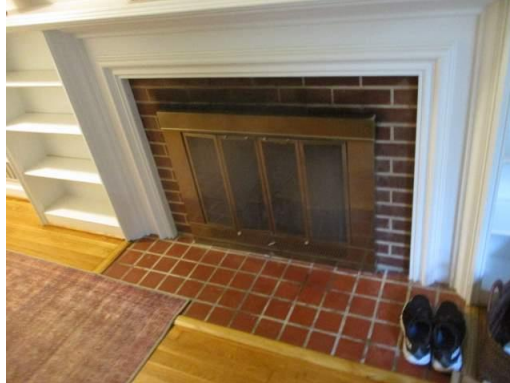
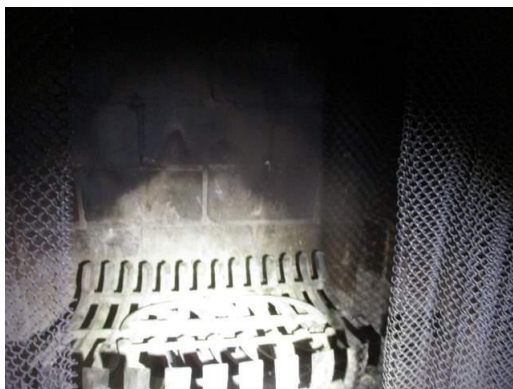
There is a masonry open wood-burning fireplace in the living room. The damper needs to be open when the fireplace is in use but should remain closed at all other times. Otherwise, it will become a significant source of heat loss during winter. Glass doors can improve the efficiency of the fireplace and can help to retain some of the heat in the house if the fire is left to burn out overnight.

Recommend cleaning and evaluation of the firebox and chimney by a licensed chimney sweep before first use. We were unable to view the full length of the chimney liner. These are often deteriorated, and chimney sweeps frequently recommend installation of stainless steel liners, which can be expensive.

Grouting improvements recommended in the hearth in front of the fireplace.

Recommend cleaning the ash pit for the wood fireplace by a qualified chimney sweep contractor.

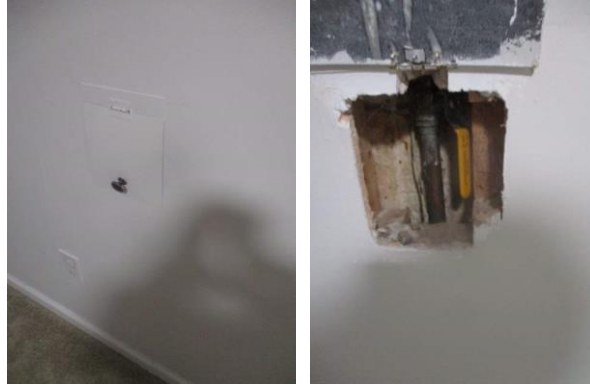
The main water shut off valve is located on the front wall of the left room in the basement.

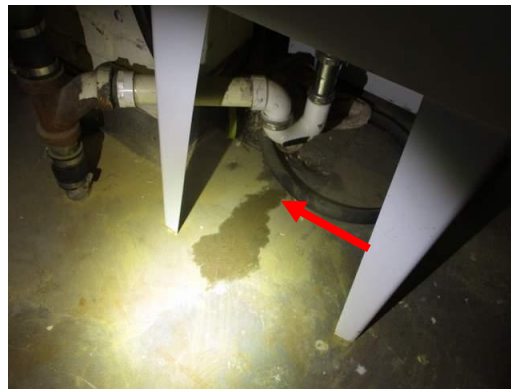
Leaking noted in the drain trap below the laundry sink. Repairs recommended by a licensed plumber.

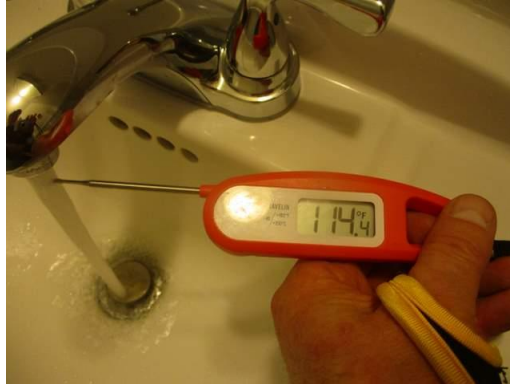
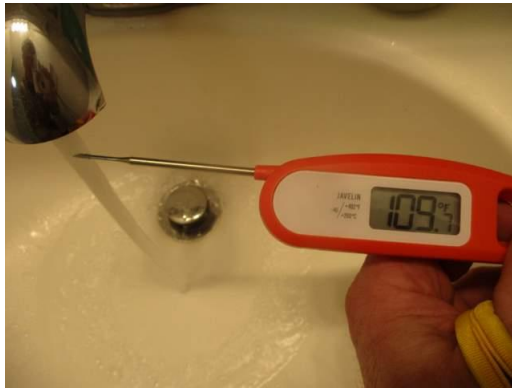
Water temperature appeared to be progressively decreasing while testing temperatures in the bathrooms and kitchen. This may indicate a malfunctioning water heater. Recommend further evaluation by a licensed plumber.

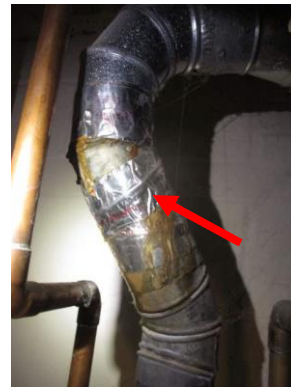
Melted plastic rings at the top of the water heater may indicate back drafting or improper operation of the unit generally caused by lack of combustion air supply. Back drafting can allow hazardous combustion gases to enter the home. Safety evaluation by a qualified professional recommended.

Foil tape is not approved to seal off combustion vents. Safety evaluation recommended.

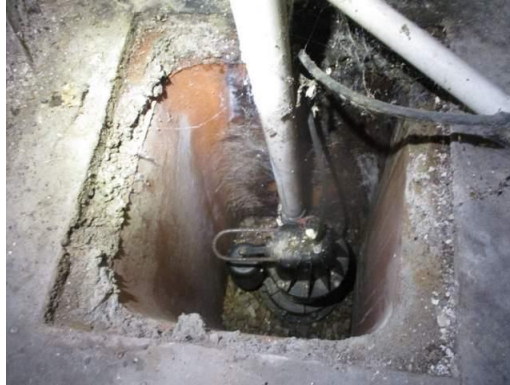
The sump pump located at the back left corner of the basement tested functional however this type of sump pit may not hold water so water from AC condensate may end up soaking into the ground beneath the floor slab. Recommend monitoring or improving.

There is no check valve for the sump pump. Recommend installing a check valve by a licensed plumber.

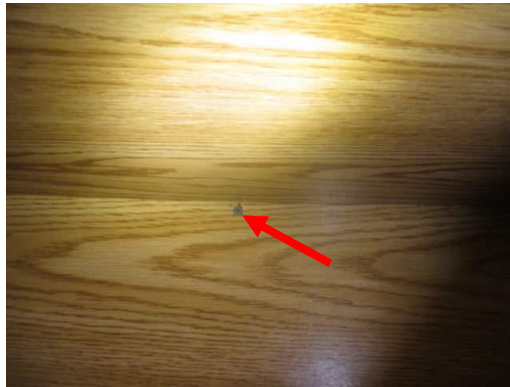
Flat-head screws have been used to secure the kitchen cabinets to the walls. This type of screw can allow the cabinet to pull past the screw due to its shape. It is recommended to install cabinets using round head screws with a large flat holding surface.

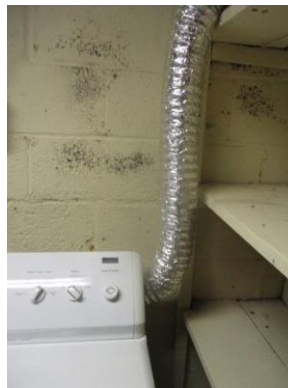
The dryer duct is not approved for use with a dryer. Recommend replacing with a duct approved for use with dryers.

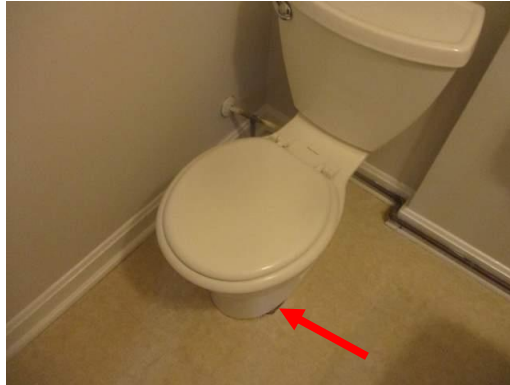
Recommend caulking where the toilet meets the floor.

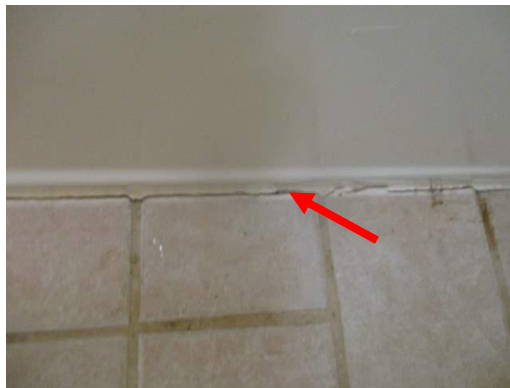
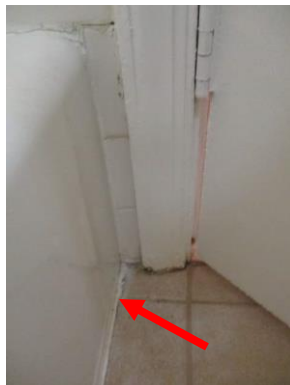
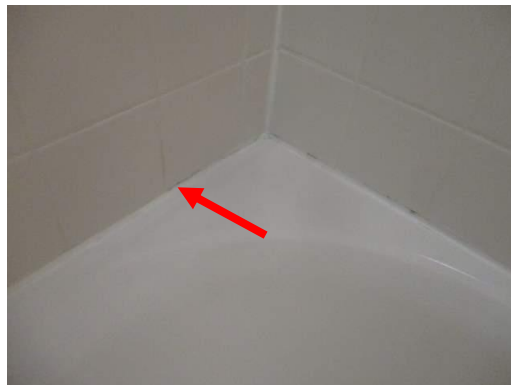
Caulking improvements needed where the tub meets the floor and where the tub meets the shower wall.

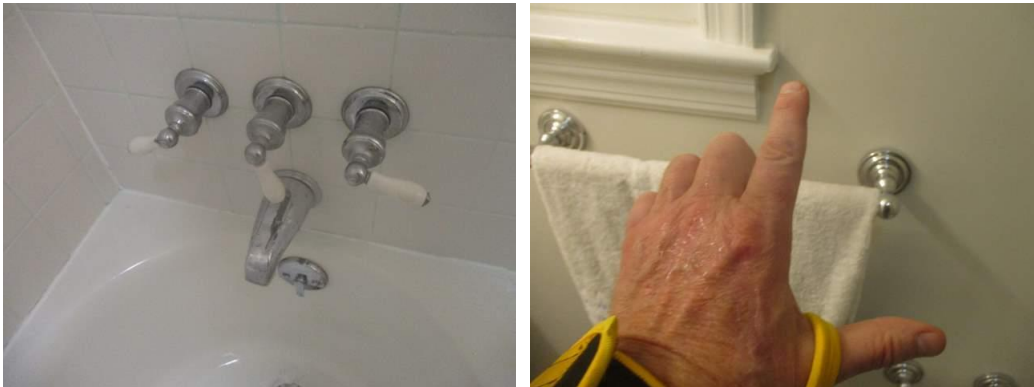
Separate hot and cold controls in the tub/shower can be a potential scalding injury hazard.

The towel rack is loose. Recommend securing.

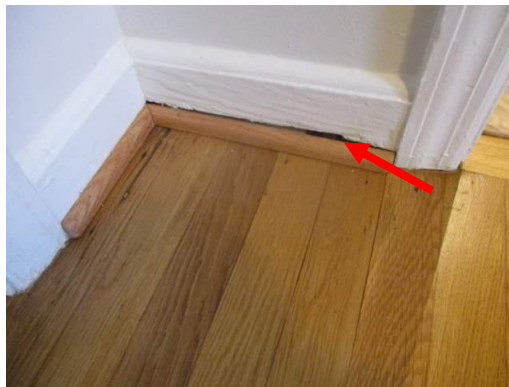
Evidence of previous moisture damage to the baseboard in the den at the back wall noted. Area tested dry at the time of inspection. Recommend sealing the gap between the baseboard and shoe molding in this area.

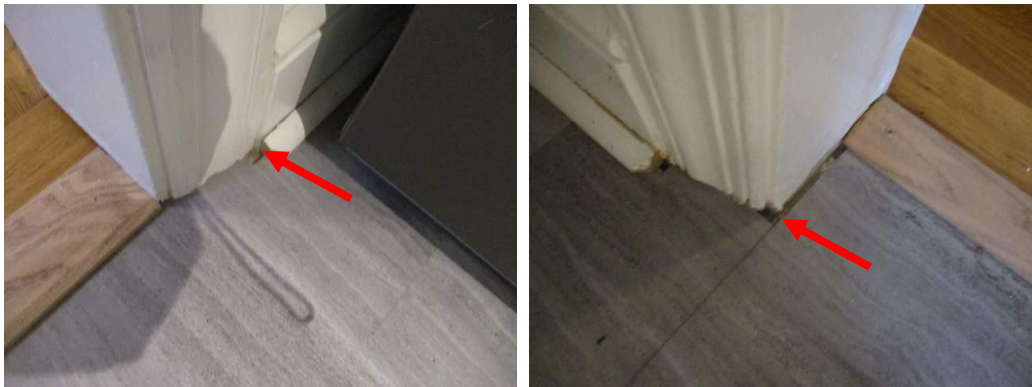
Gaps noted around the perimeter of the kitchen floor. Recommend sealing the gaps by a qualified flooring contractor.

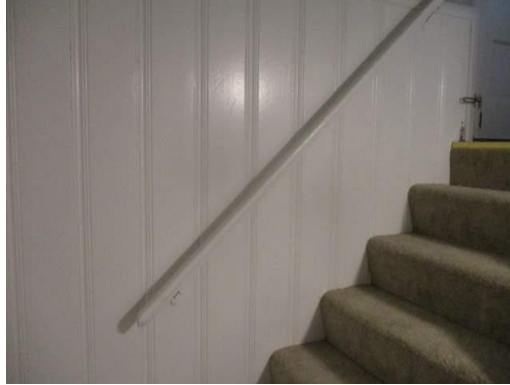
Recommend replacing the basement stairwell handrail with a handrail that turns to the wall and is attached. In addition, also recommend installing a handrail for the top three stairs.

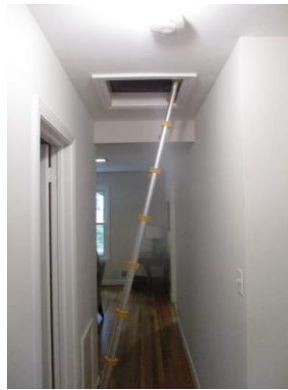
We entered the attic with a ladder through the scuttle in the hallway. The access hatch is ½ inch plywood, not insulated. Recommend insulating the attic hatch.

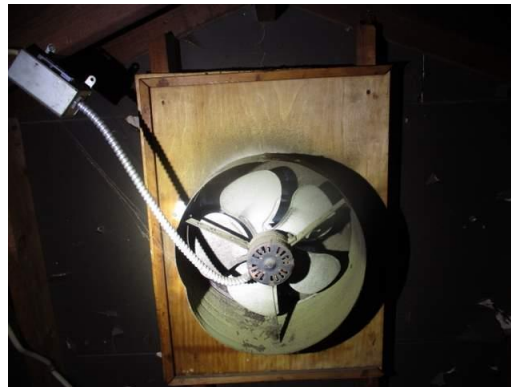
The attic fan did not turn on when tested. Recommend further evaluation.
